HERITAGE STATEMENT
RETROSPECTIVE LISTED BUILDING CONSENT APPLICATION
FOR THE INSTALLATION OF BRICK FACE TO CHIMNEY, AIR BRICK AND
TWO STOVES WITH FLUE LINERS

Weavers Cot

June 2018

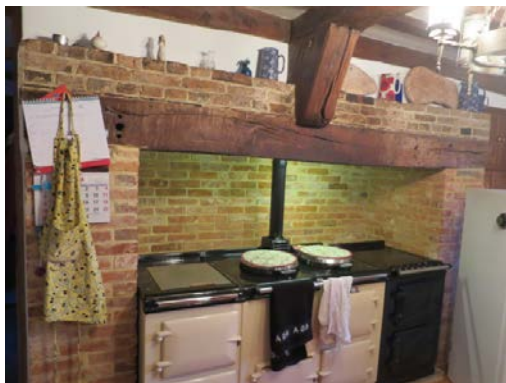
Fig. 3- The west elevation with rear wing

A) **Installation of a brick skin to the kitchen chimney opening.**

Relatively modern tiles, which can still be seen in other parts of the kitchen, were removed from the kitchen chimney opening, around the Aga.

Once tiles were removed, the owner found the brickwork behind to be in very poor condition with soft and crumbling bricks.

An additional half brick skin of reclaimed 'Tudor Red' bricks were installed around the perimeter of the chimney opening to produce a suitable finish and protect the older bricks.

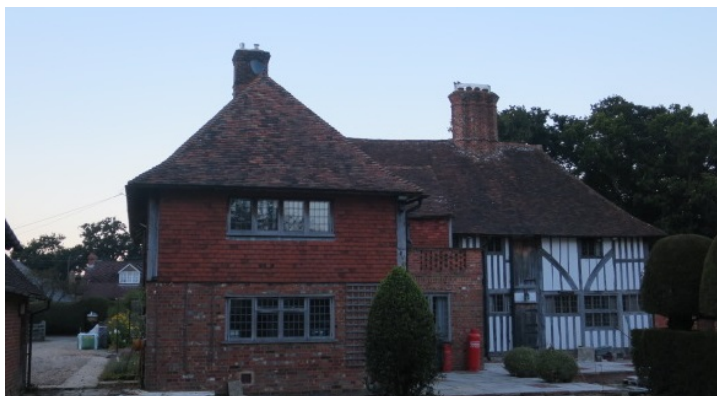
Fig. 5- Airbrick shown in south elevation of rear wing

B) **Installation of a ceramic airbrick in the utility room lower south wall**

An airbrick was installed at low level within the utility room to provide much needed natural ventilation to a humid room through the external wall.

A ceramic airbrick has been used and installed at low level instead of using a high level mechanical extractor with modern vents.

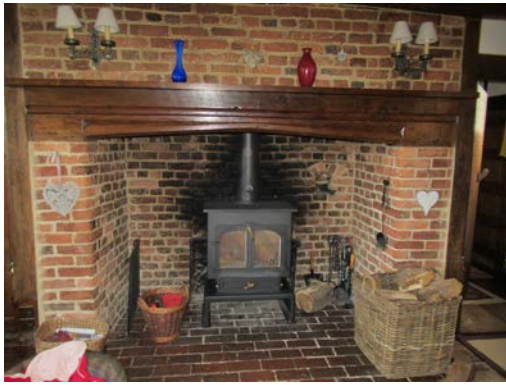
Fig. 6-Living room stove

C) **Installation of a new stove and metal liner to the living room.**

The fireplace was used with a fireback and grate but was not producing enough heat for the large rooms and slender external walls.

A Clearview 750 stove has been installed with a new register plate and metal flue up through the existing brick flue.

The older fireback has been retained in the fireplace.

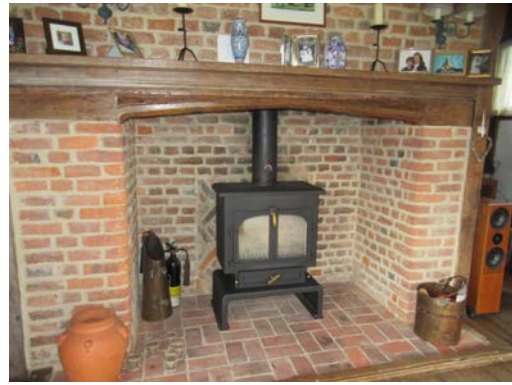
Fig. 7- Sitting room stove

D) **Replacing existing stove and installation of a register plate and new metal liner to the sitting room.**

The fireplace was used with a stove in the existing fireplace opening.

A Clearview 750 stove has been installed with a new register plate and metal flue up through the existing brick flue.

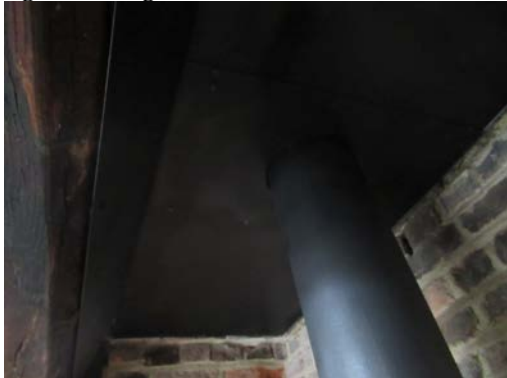
Fig. 8- Sitting room register plate
